Manhole Inspection Summary

Manhole # S02WW1018MH

Insp Date: **8/15/06 12:00 AM**

Location Address: **3712 Foorls Ln**

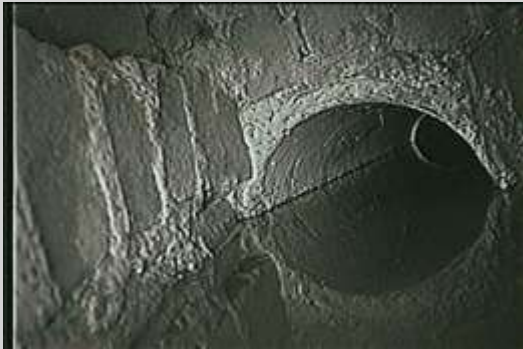
8 in. Circular Gravity Sewer Pipe Out @ 12 O'Clock

Pipe Material: **Clay** ☐ Pipe Lined

Invert Depth: **10.30** (ft.) Flow Characteristics: **Slow**

Deposits: ☒ None ☐ Mud ☐ Sludge ☐ Debris ☐ Grease

Infiltration: **None** Pipe Seal Cond: **Sound**

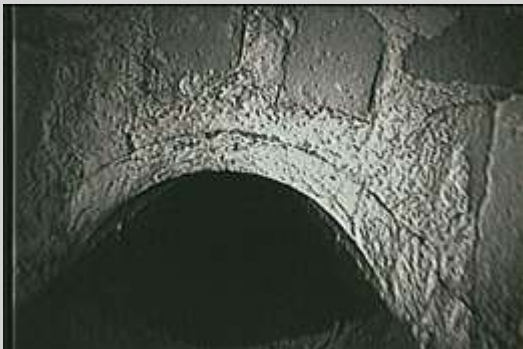
8 in. Circular Gravity Sewer Pipe In @ 6 O'Clock

Pipe Material: **Clay** ☐ Pipe Lined

Invert Depth: **10.30** (ft.) Flow Characteristics: **Slow**

Deposits: ☒ None ☐ Mud ☐ Sludge ☐ Debris ☐ Grease

Infiltration: **None** Pipe Seal Cond: **Sound**
